Manhole Inspection Summary

Manhole # S43A2_006MH

Location Address: **3745 10th St**

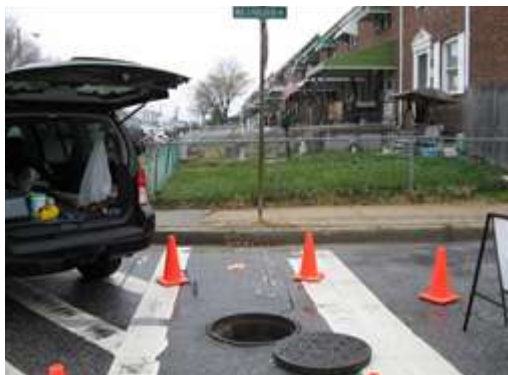
Location View

Washburn Ave.

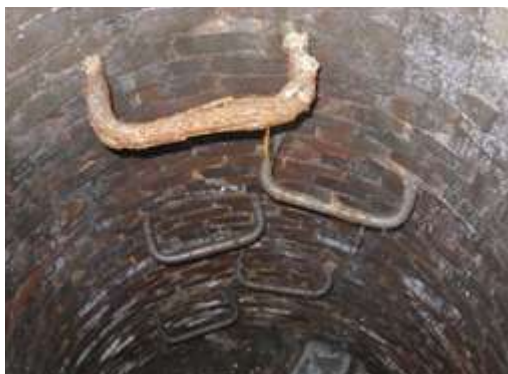
Defect 2

Above grade

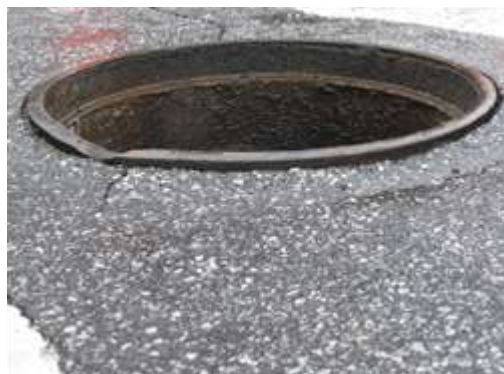
Defect 1

Offset: **2.5** (in.)

Frame offset

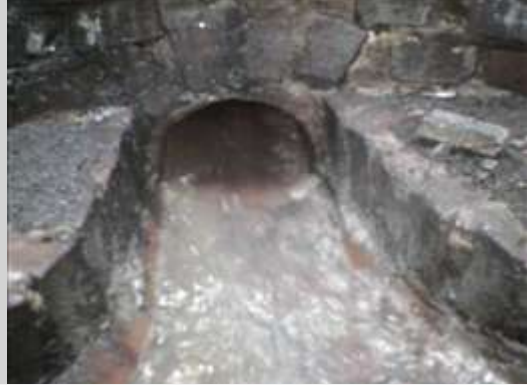
12 O'Clock Outflow

8 in. Circular Gravity Sewer
Pipe Out @ 12 O'Clock

Pipe Height: **9.6** (in.) Rod and Bar (Angled)
Pipe Material: **Clay** ☐ Pipe Lined
Invert Depth: **10.40** (ft.) Flow Characteristics: **Fast**
Deposits: ☒ None ☐ Mud ☐ Sludge ☐ Debris ☐ Grease
Silt Depth: (in.) Deposits Extent:
Infiltration: **None** Pipe Seal Cond: **Sound**

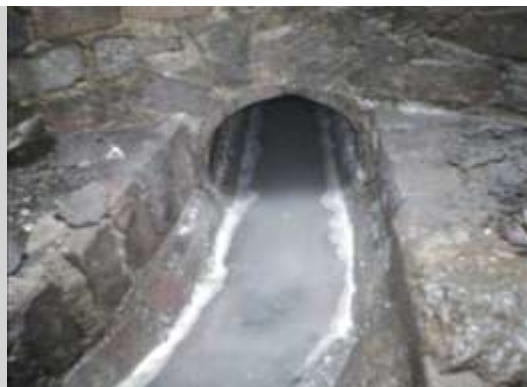
3 O'Clock Inflow

8 in. Circular Gravity Sewer
Pipe In @ 3 O'Clock

Pipe Height: **10.8** (in.) Rod and Bar (Angled)
Pipe Material: **Clay** ☐ Pipe Lined
Invert Depth: **10.46** (ft.) Flow Characteristics: **Slow**
Deposits: ☒ None ☐ Mud ☐ Sludge ☐ Debris ☐ Grease
Silt Depth: (in.) Deposits Extent:
Infiltration: **None** Pipe Seal Cond: **Sound**

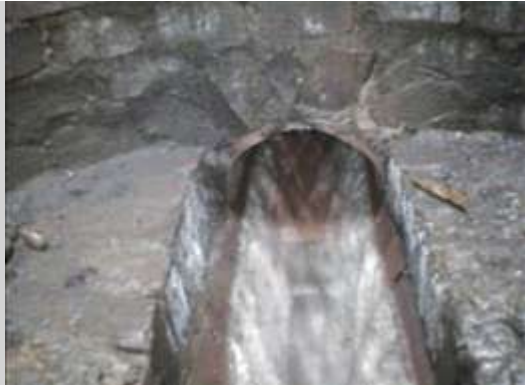
6 O'Clock Inflow

8 in. Circular Gravity Sewer

Pipe In @ 6 O'Clock

Pipe Height: **9.6** (in.) Rod and Bar (Angled)

Infiltration: **None** Pipe Seal Cond: **Sound**

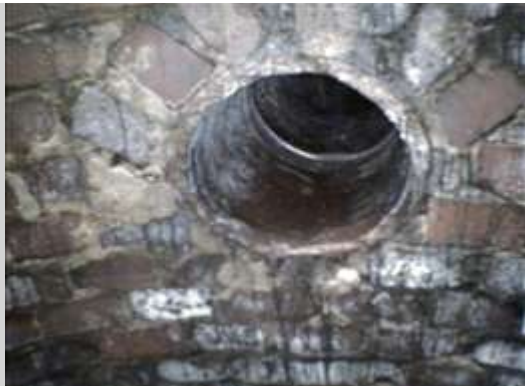
9 O'Clock Inflow

8 in. Circular Gravity Sewer

Pipe In @ 9 O'Clock

Pipe Height: **10.8** (in.) Rod and Bar (Angled)

Infiltration: **None** Pipe Seal Cond: **Sound**

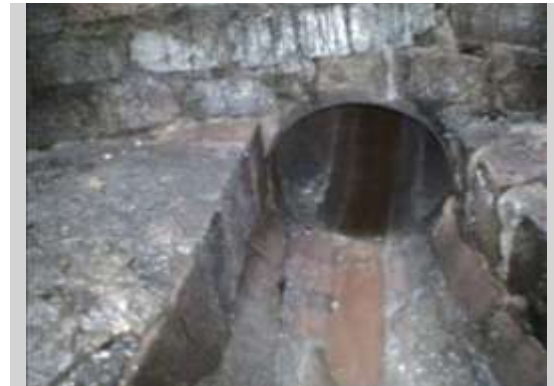
Drop In @ 9 O'Clock

Drop: **Outside** Rod and Bar
Angled: **Yes** Reading: **9.19** (ft.)
Inv Depth: **10.19** (ft.)

Drop Condition: **Open**
